# Distinctive Strategies and Approach For Breakthrough Performance

# Promethean Decommissioning Capabilities

## 2025 Case Study

Leaking Well on Listing Three Pile  
Fixed Structure In GAO

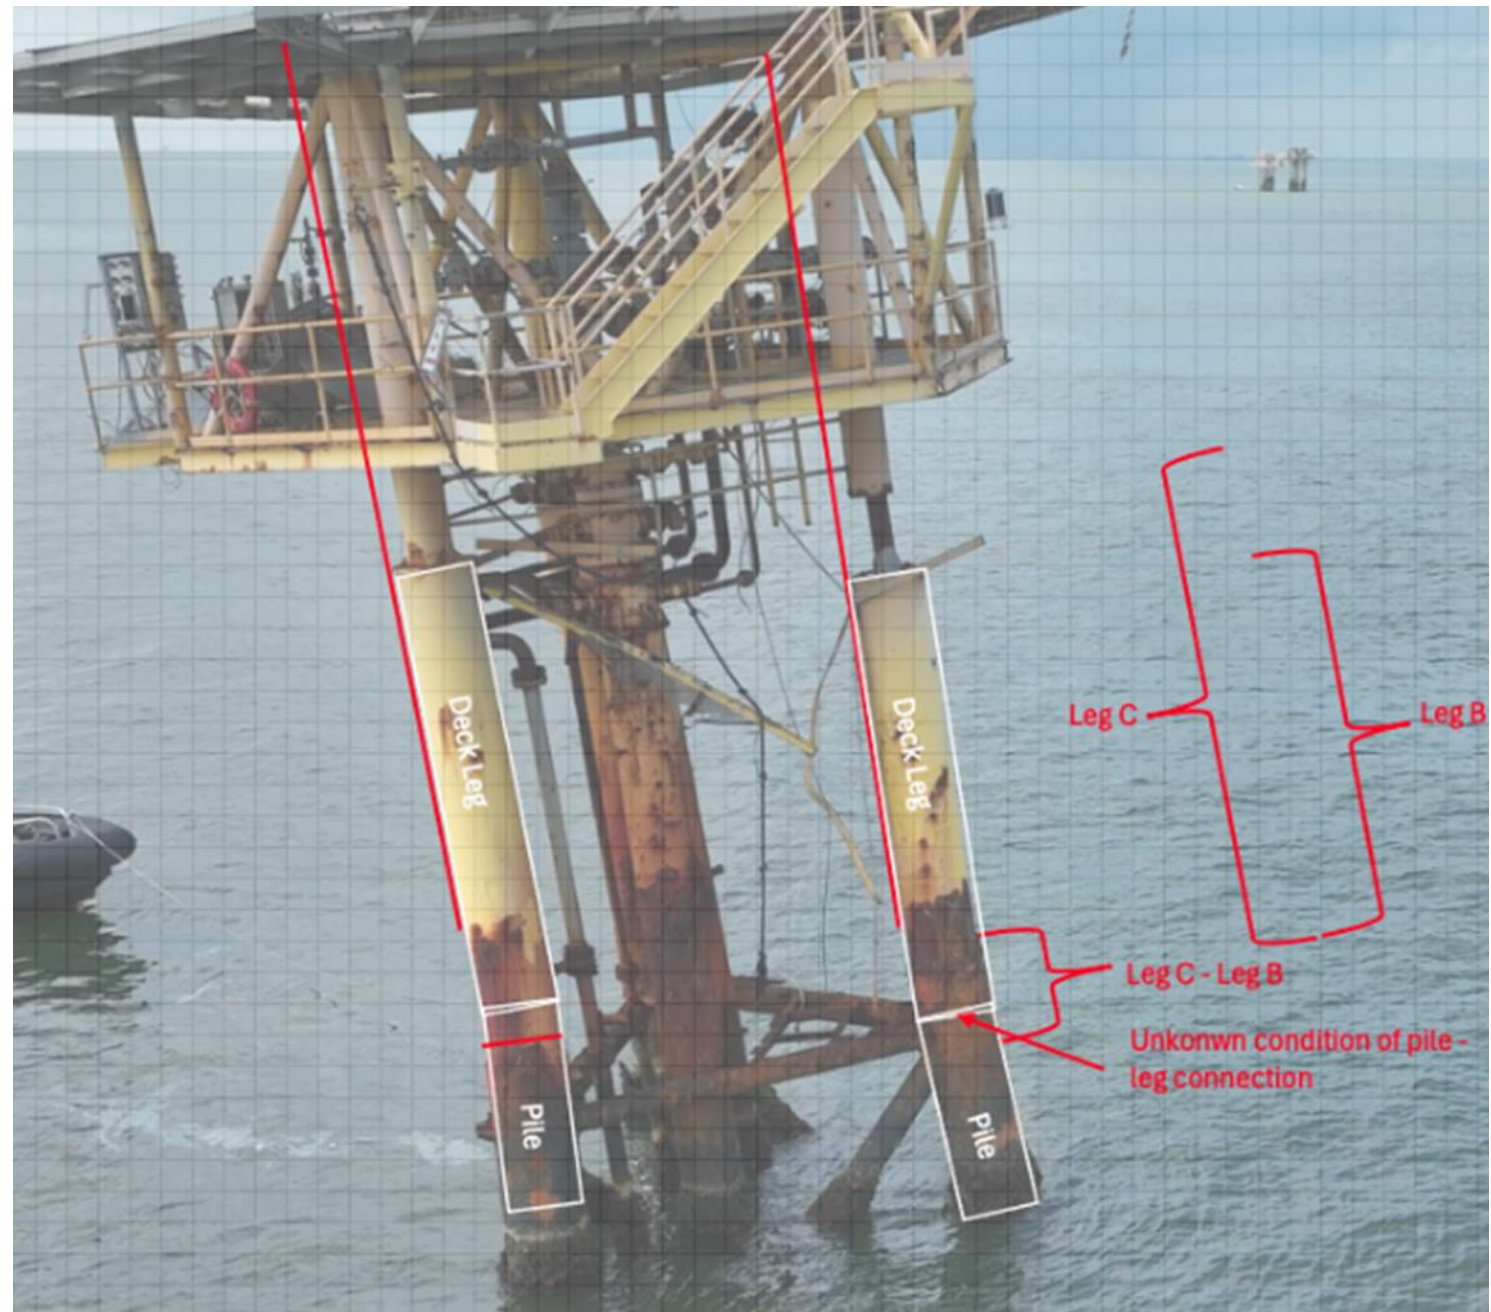
# Risk 1

## Jacket-Pile-Deck Leg Structural Instability

- Platform listing at 12°
- Jacket-pile-deck stab connection failed
- Only 2 of 3 attachment points intact

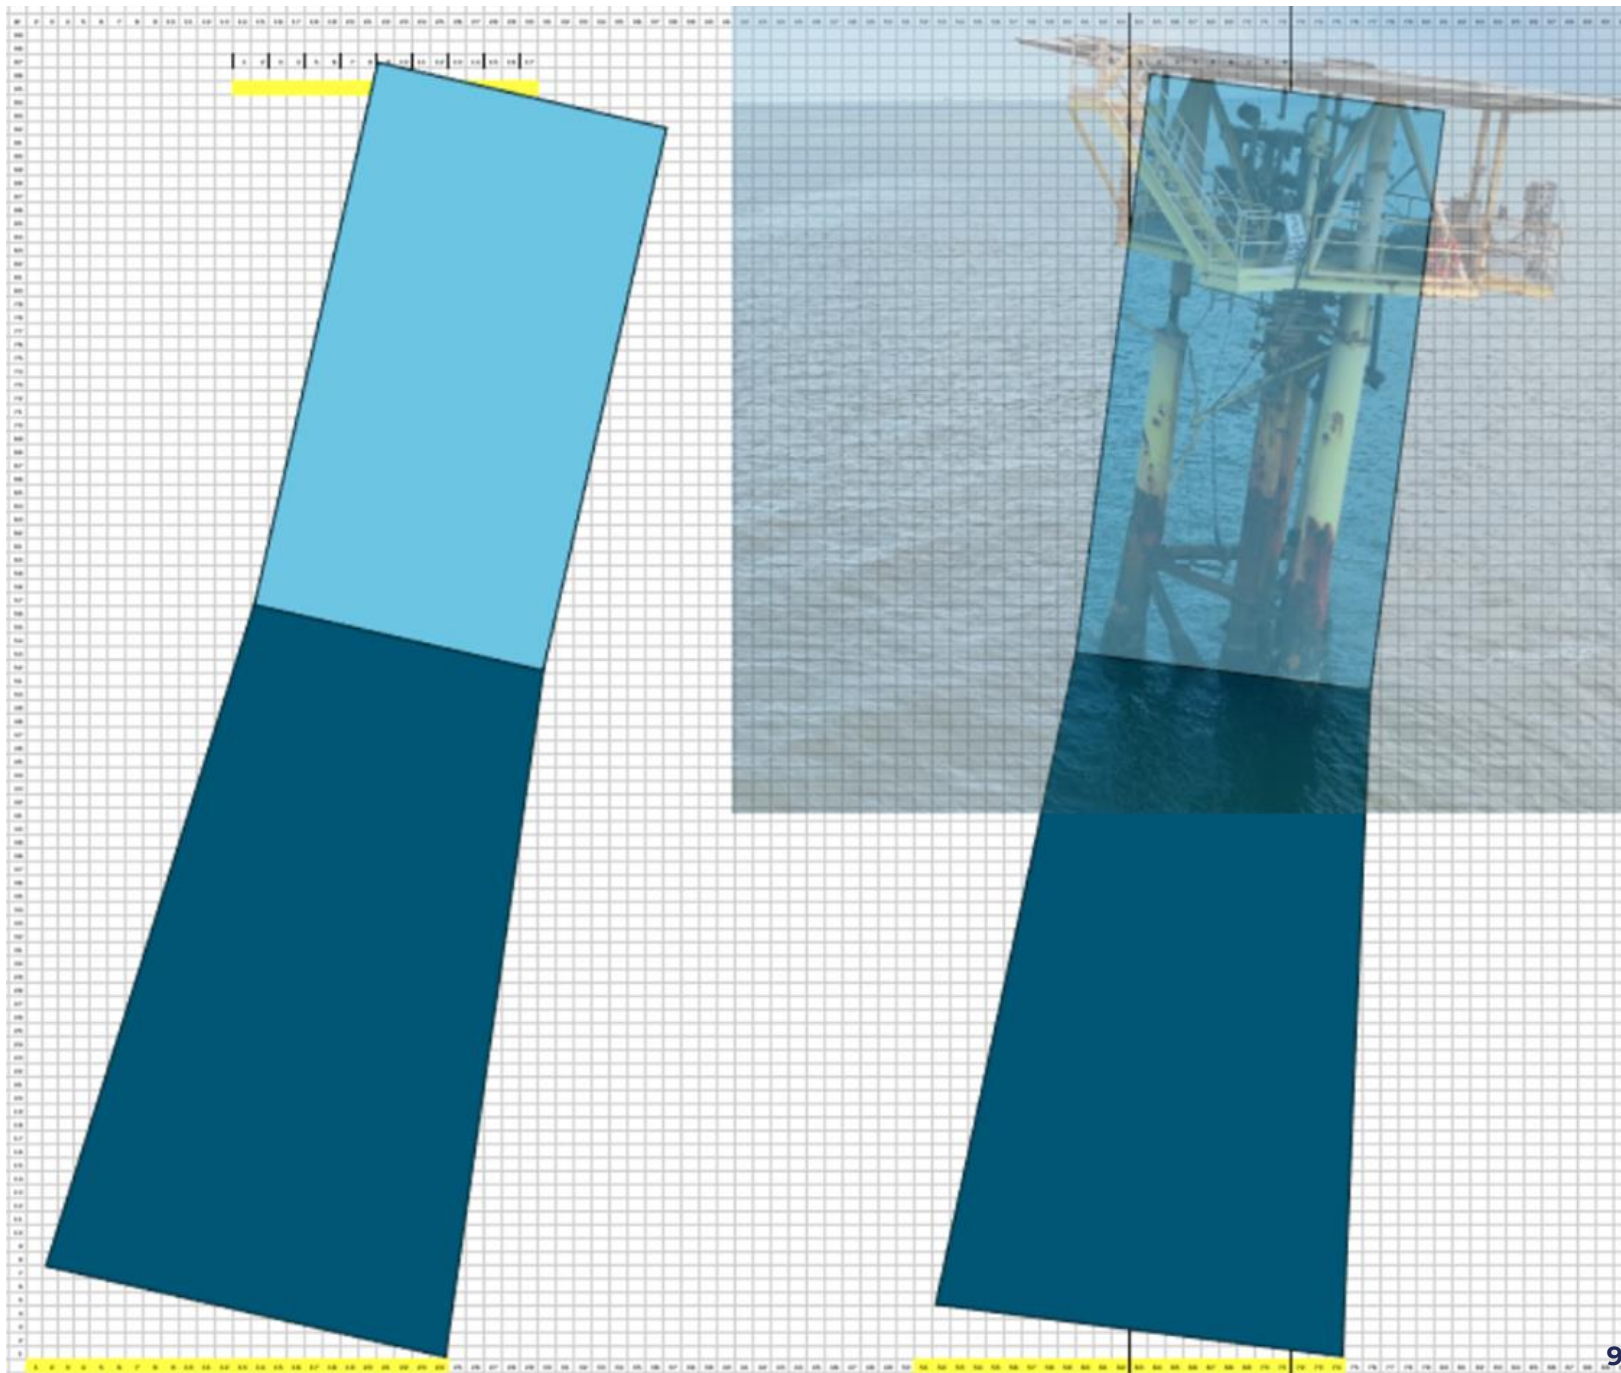
# Risk 2

## Center of Gravity Offset

- 12° list shifted CoG outside stable envelope
- Lateral overturning moment
- Vertical instability

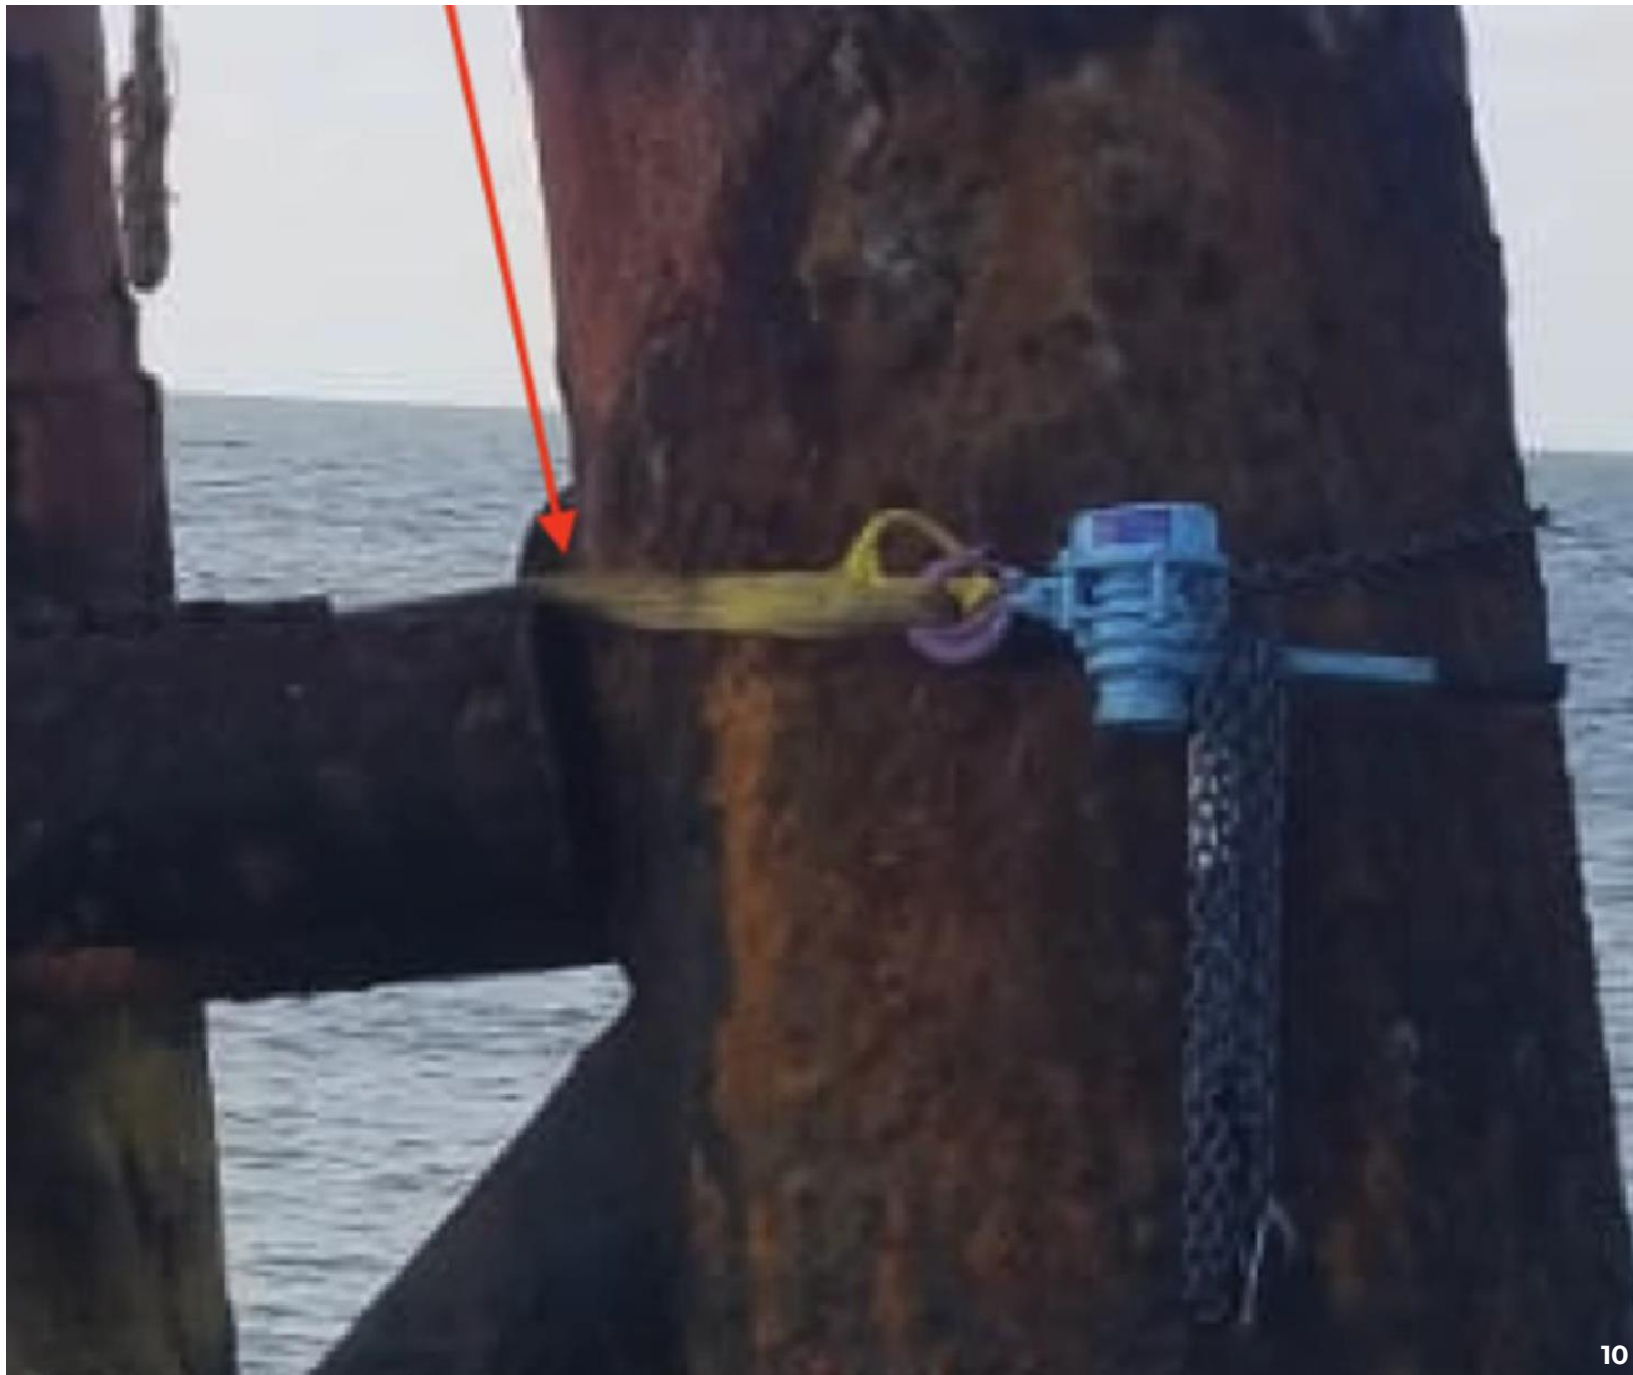
# Risk 3

## Jacket Cross Member Failure

- Corroded and separated cross members
- Structural rigidity compromised
- Below original design criteria

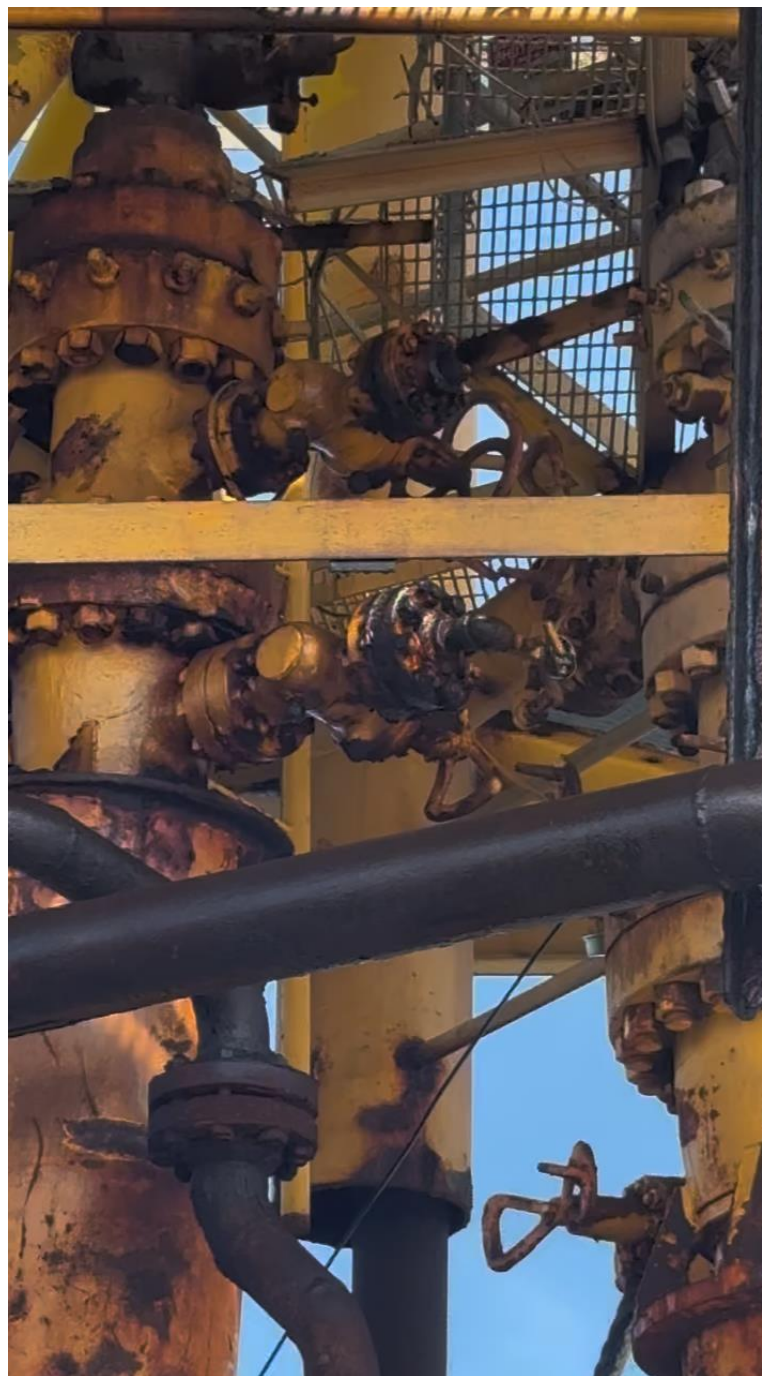
# Risk 4

## Well Conductor Displacement & Potential Tubing Deviation

- Wellhead rocking continuously
- Valve stem broke off
- High probability that tubing kinked

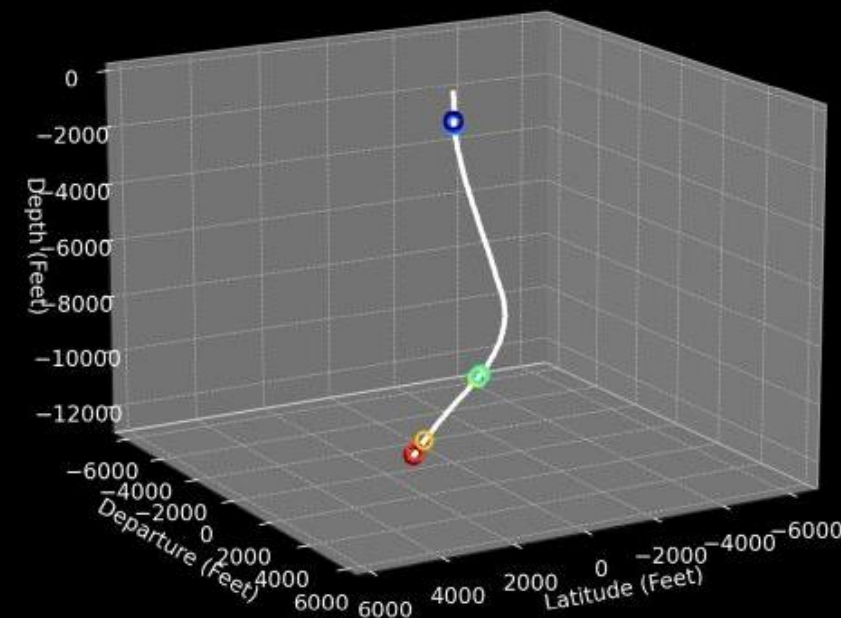
## HIGH DOG LEG DEPTHS & SEVERITY

- 971 ft - DLS 3.38°
- 1042 ft - DLS 3.78°
- 1132 ft - DLS 3.72°
- 9963 ft DLS 4.51°
- 10056 ft - DLS 4.06°
- 12115 ft - DLS 3.14°
- 12493 ft - DLS 4.00°
- 12614 ft - DLS 3.01°

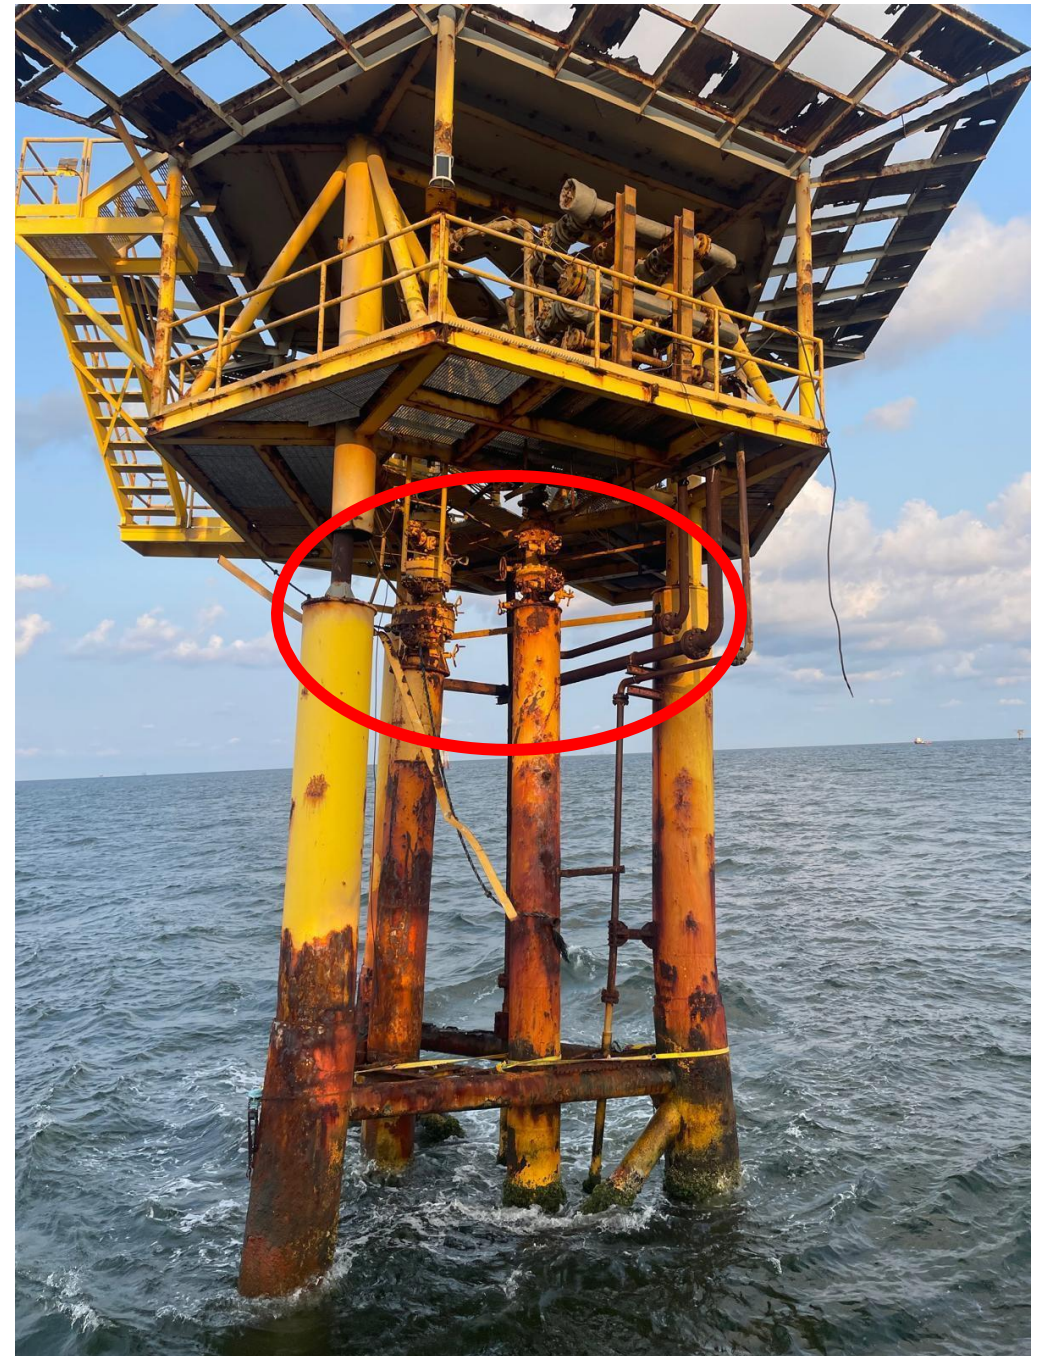
# Risk 5

## Lack of Wellhead Access Below Deck

- Working at 12 deg incline
- Difficult to access & work on
- P&A on hold until resolved
